Tank Inspection Checklist: Walk-around #1

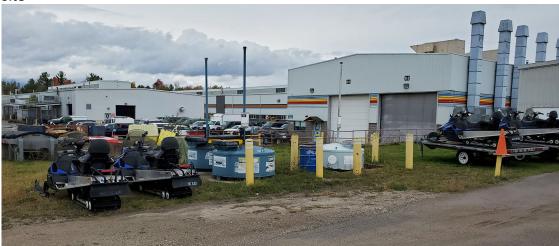
Site

Overall site is away from traffic – some vehicles and trailers are parked around the site. Tarps are lying nearby.

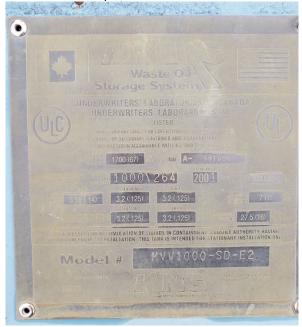
Certification is for waste oil only – have gas, diesel and antifreeze.

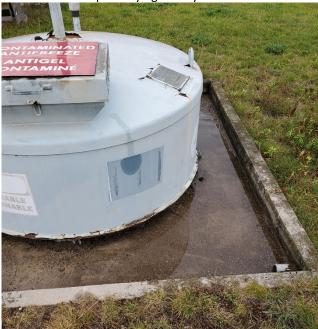
Tank is below grade and filled curbs are concrete is filled with water; no place to drain out; possibility of oily-water spill.

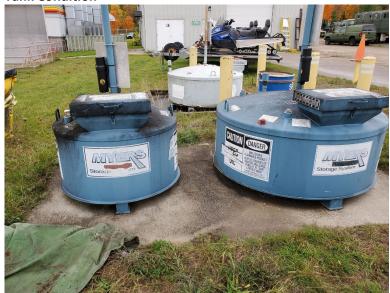
Blackened tanks – likely from exhaust from vehicles parked near the tanks: demonstrates vehicles have been parked close by.

Soot! Clean off soot – to make all signage readable.

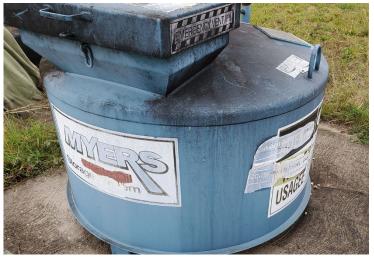
Waste oil is stroked out - remove and affix appropriate signage.
